Jon Batts v. Remington Arms Company, LLC

Expert Report – Firearm & Incident Analysis

Prepared by: Derek Watkins

Date: 07/15/2019

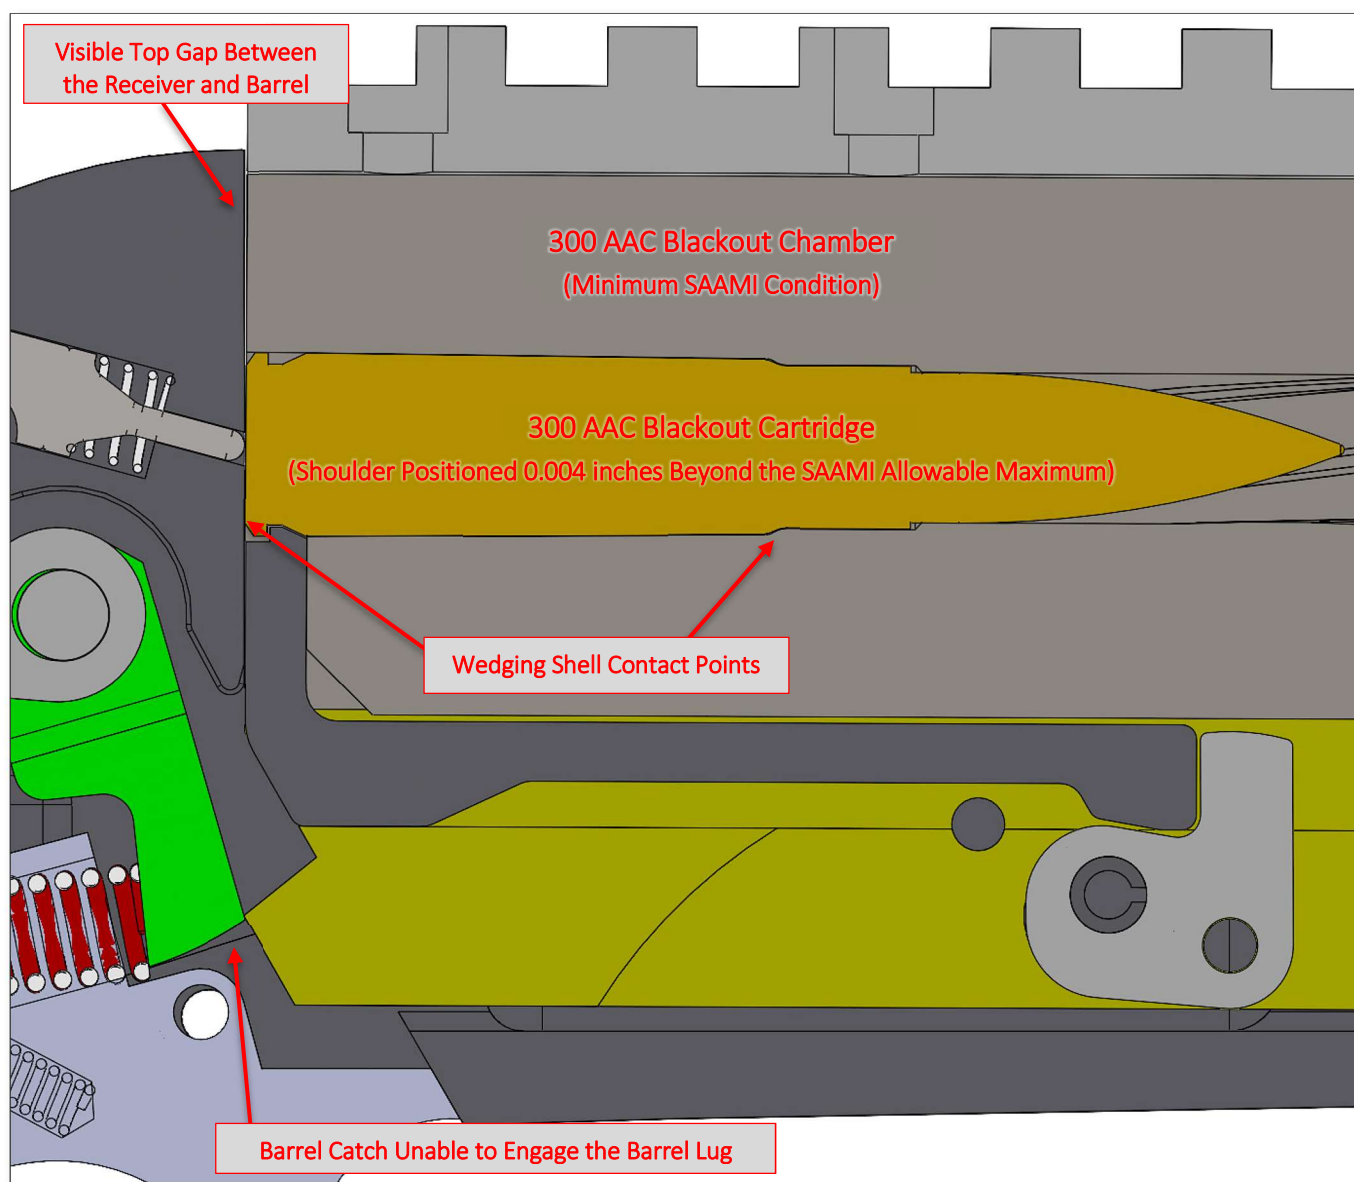
Figure 5.2.1: An Improperly Formed Cartridge Preventing the Action of an H&R Handi-Rifle from Locking

Figure 5.2.1 shows how a 300 Blackout cartridge with an improperly formed shoulder (0.004 inches beyond the SAAMI spec) can wedge the cartridge between the breech face and the shoulder of the chamber and prevent the barrel assembly from fully closing and locking. The dimensions of SAAMI compliant chambers and cartridges have tolerances which establish a minimum and maximum condition. Depending on the dimensions of the chamber, the inability to lock can occur with an improperly formed cartridge that places the base of the shell between 0.004 and 0.009 inches beyond the minimum headspace condition for the rifle.

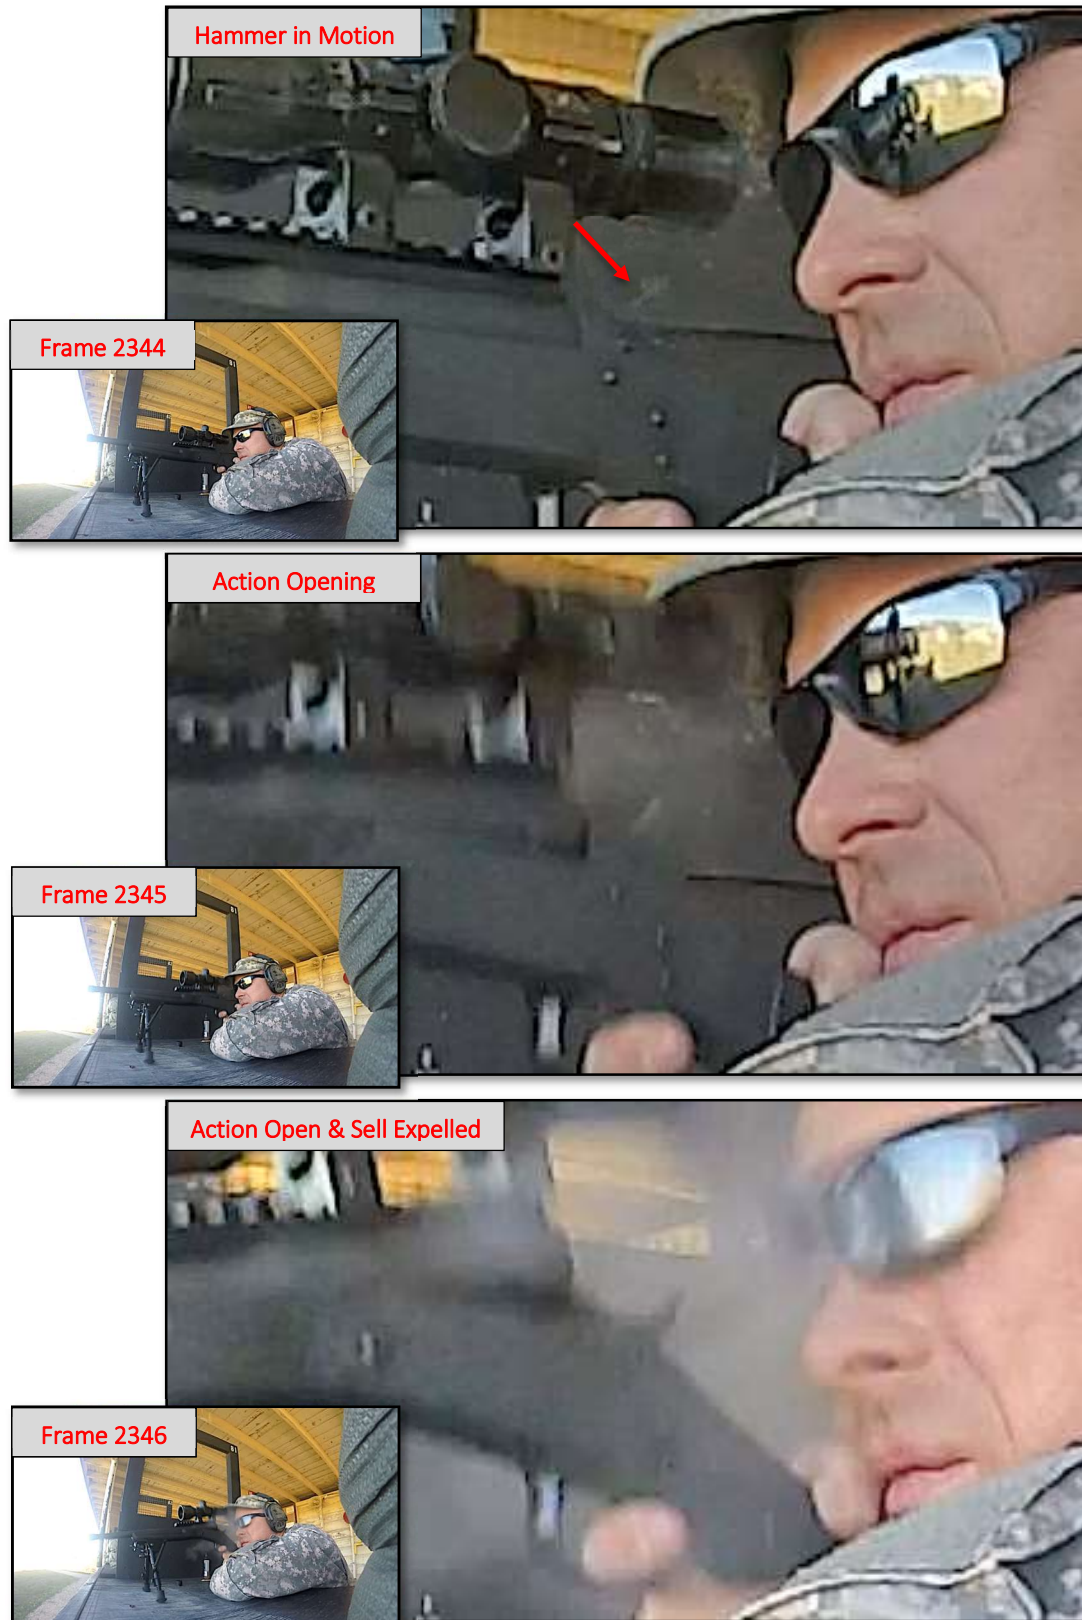
Figure 6.1: Incident Video Frames Taken from the GoPro Video GOPR5588.

On the date of the incident, Mr. Batts was employing a GoPro HD video camera to record his shooting activities. Three videos were recorded on the date of the incident (GOPR5586, GOPR5587 and GOPR5588), all of which were recorded in 1920 x 1080p at 60 frames per second (fps) with a 48kHz audio track. Video GOPR5586 is a recording of Mr. Batts shooting his M1A rifle, video GOPR5587 was deleted from the camera's memory card and video GOPR5588 is a recording of the incident. Having these videos affords the rare opportunity to analyze the incident as it occurred and gain insight into the events that led up to the incident.

Mr. Batts was shooting 300 Blackout ammunition at the time of the incident. In a rifle equipped with a 16-inch barrel (such as the subject rifle) SAAMI compliant 300 Blackout ammunition can have a bullet-in-barrel-time as little as 0.8 milliseconds and as long as 1.4 milliseconds, depending if the ammunition is supersonic or subsonic. Figure 6.1 shows three consecutive video frames of the incident rifle being shot and opening (frames 2344, 2345 and 2346). Frame 2344 shows the rifle's hammer in the process of falling after the trigger has been pulled (the cartridge in the chamber has not yet discharged). Frames 2345 and 2346 show the rifle's action opening and opened respectively. See Figure 6.1. Because the video was recorded at 60 fps, the duration of each frame of video is 0.0167 seconds (16.7 milliseconds). Therefore, given the three frames of video, we can derive the time from the hammer hitting the firing pin to the time the action opened and the shell started to be expelled was between 16.7 milliseconds and 33.4 milliseconds. This action-opening-dwell-time is considerably longer than the bullet-in-barrel-time for SAAMI compliant 300 Blackout ammunition in a 16-inch barrel. This discrepancy between the action-opening-dwell-time and the bullet-in-barrel-time indicates the incident round of ammunition did not perform per SAAMI specifications.

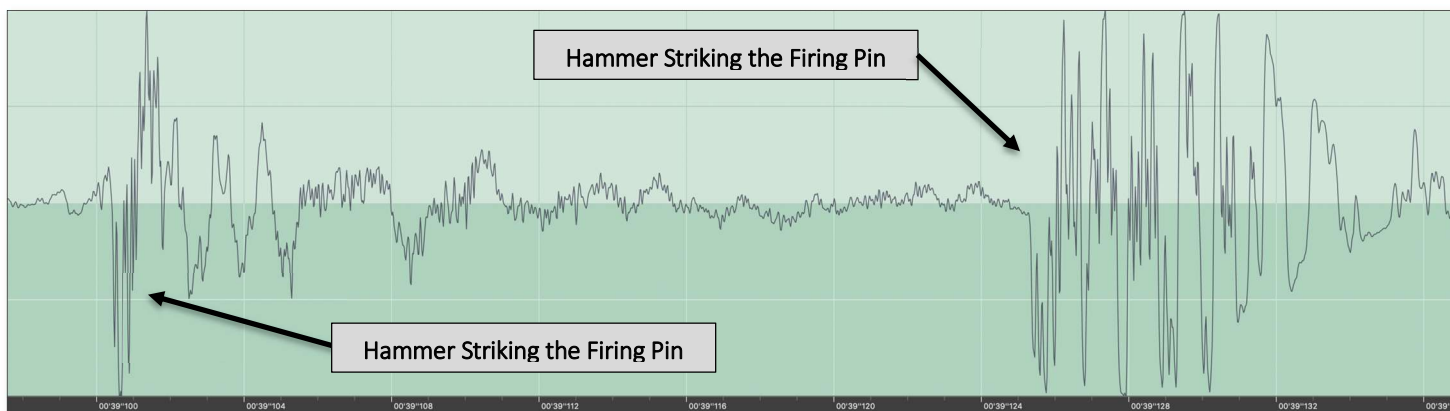
Figure 6.2: Incident Audio Waveform of the Hammer Striking the Firing Pin and the Shell being Ejected.

Per the videos, Mr. Batts had positioned the GoPro camera within a few feet of the rifle. This positioning of the camera allowed the microphone to pick up even subtle events. The audio wave form of the incident shot showed a double event. See Figure 6.2. The audio event on the left side of the waveform is the hammer striking the firing pin and the audio event on the right side of the waveform is the shell being expelled from the open action. Per the incident audio waveform, we can calculate the action-opening-dwell-time to be approximately 25 milliseconds. If a SAAMI compliant subsonic 300 Blackout bullet has a

bullet-in-barrel time of 1.4 milliseconds, the incident 25 millisecond action-opening-dwell-time proves the incident cartridge did not perform to SAAMI standards because the SAAMI compliant bullet would have left the barrel 23.6 milliseconds before the action would have the opportunity to open far enough for the shell to be expelled.

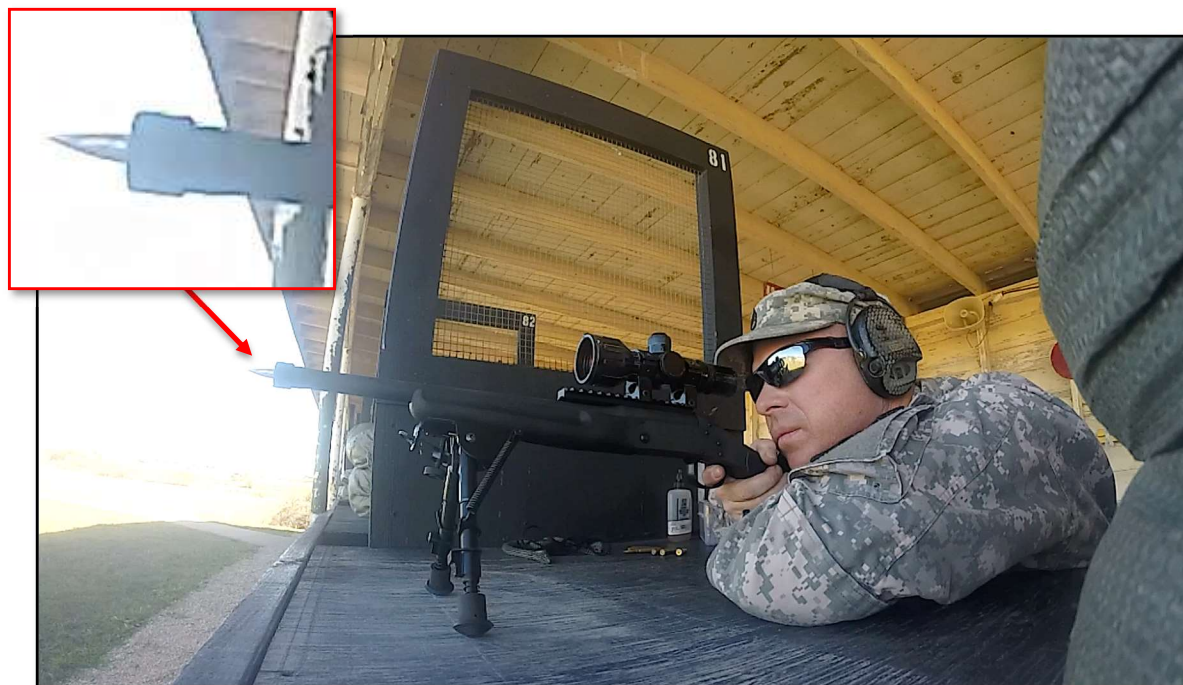
Figure 6.3: Video Frame from the First 300 Blackout Cartridge Fired on Video GOPR5587.

Using video recovery software (GoPro Recovery™), the deleted video GOPR5587 was recovered from the GoPro's memory card. The first 300 Blackout cartridge fired by Mr. Batts lodged the bullet in the end of the barrel (squib load). See Figure 6.3. The failure of the first bullet fired to exit the barrel indicates the ammunition was significantly under powered and not to SAAMI specifications. It is at this point Mr. Batts should have stopped shooting the 300 Blackout ammunition, as it was producing clear signs of being dangerously defective.

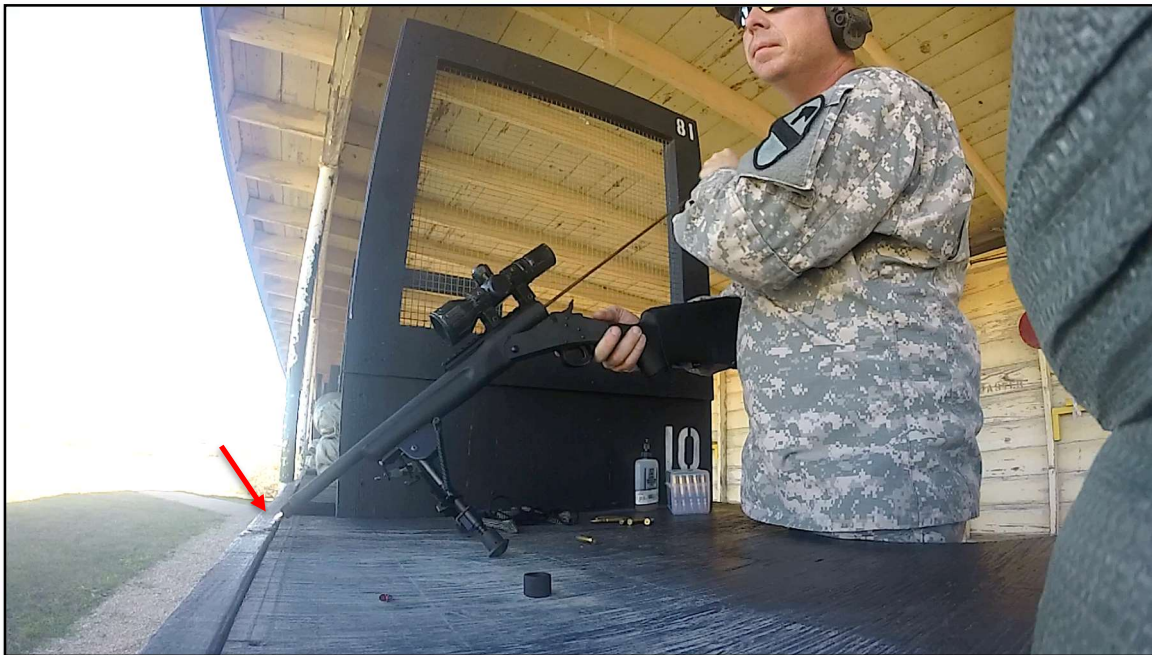
Figure 6.4: Mr. Batts Clearing the Bore Obstruction from After the First 300 Blackout Cartridge Discharge

Video Gopr5587 also shows Mr. Batts used a ram rod to clear the lodged bullet from the barrel. See Figure 6.4. Mr. Batts then ran a bore snake (barrel cleaning implement) through the barrel and then added CLP (a cleaning and lubricating protectant) to the chamber and bore after clearing the obstruction. The excessive discharge smoke seen in the second shot (first shot of video Gopr5588) was caused by the CLP in the bore.

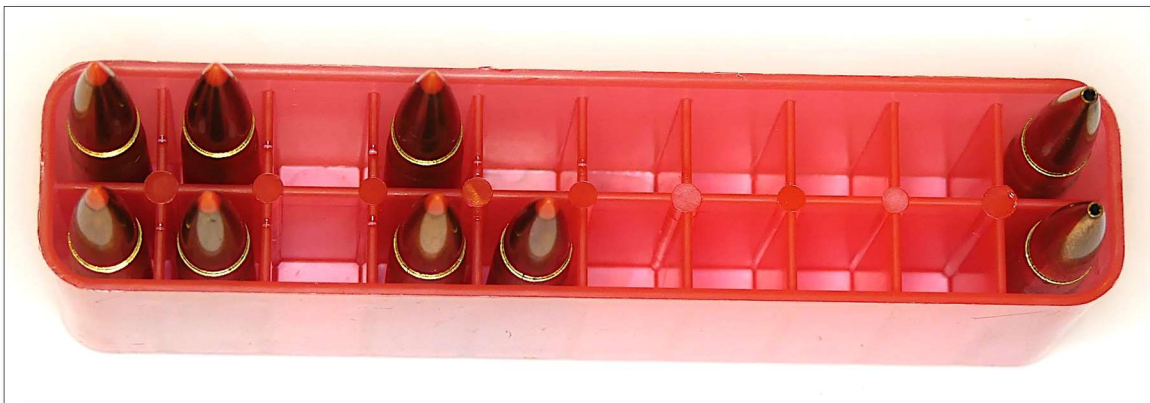
Figure 8.1.1: Subject Unfired Cartridges Presented for Inspection

Nine unfired cartridges were presented for examination. These nine unfired cartridges were represented as being the ammunition Mr. Batts was using on the day of the incident. See Figure 8.1.1. The cartridges were presented in a red translucent 20 round reloaders ammo box. This ammo box is not the translucent gray 50 round reloader's ammo box present in the GoPro videos or Mr. Batts' Facebook photos.

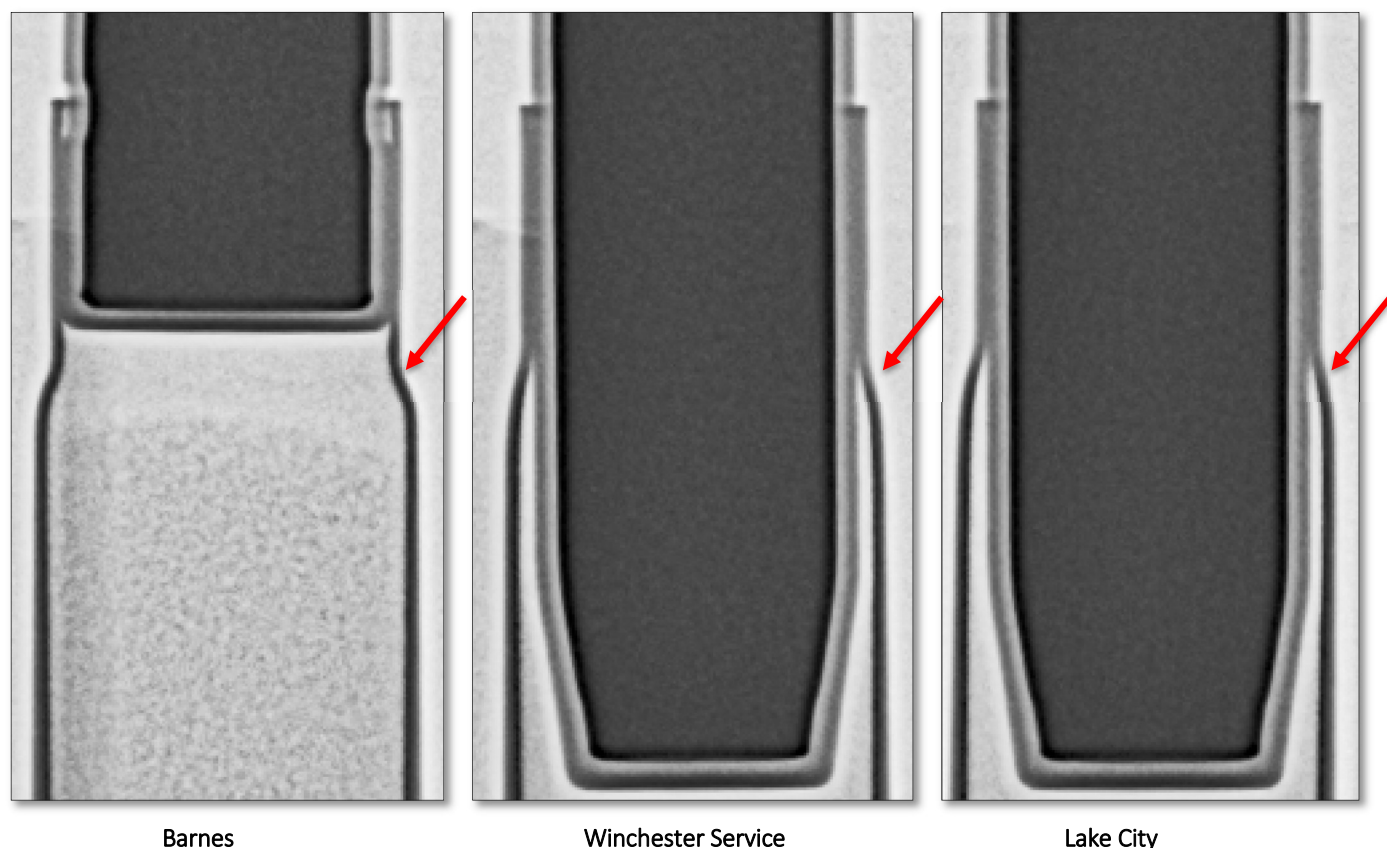
Figure 8.1.4: Shoulder Geometry of the Three Types of Shells Compared

Because the single Lake City cartridge utilized a resized/repurposed military 5.56mm NATO shell, the conclusion can be made that the cartridge is a reload (not factory). The case head showed the shell’s production year was 2004. A heavy ejector mark had deformed the “L” stamp, indicating the shell had possibly been previously fired through a machinegun with a fixed ejector, like the MK46 or M249. Dimensionally, the overall cartridge length and shell length were within SAAMI limits. Mr. Powell used a shell gauge

to show the base to shoulder length was 0.005 inches above specification. The shoulder of a shell establishes the headspace for that shell. Use of the Lake City cartridge could exceed the headspace gap of a rifle's chamber and cause the rifle not to lockup when closed. The x-ray examination of the shoulder geometry showed it was not well formed and may not fit a SAAMI chamber properly. See Figure 8.1.4.

The six Winchester cartridges also utilized resized/repurposed military 5.56mm NATO shells and were reloads (not factory). Dimensionally, the overall cartridge lengths and shell lengths were within SAAMI limits. The geometry of the shoulder on these shells were weak/not well formed, indicating these shells were newly formed from the original 5.56mm shell and had never been discharged in a 300 Blackout rifle. See Figure 8.1.4.

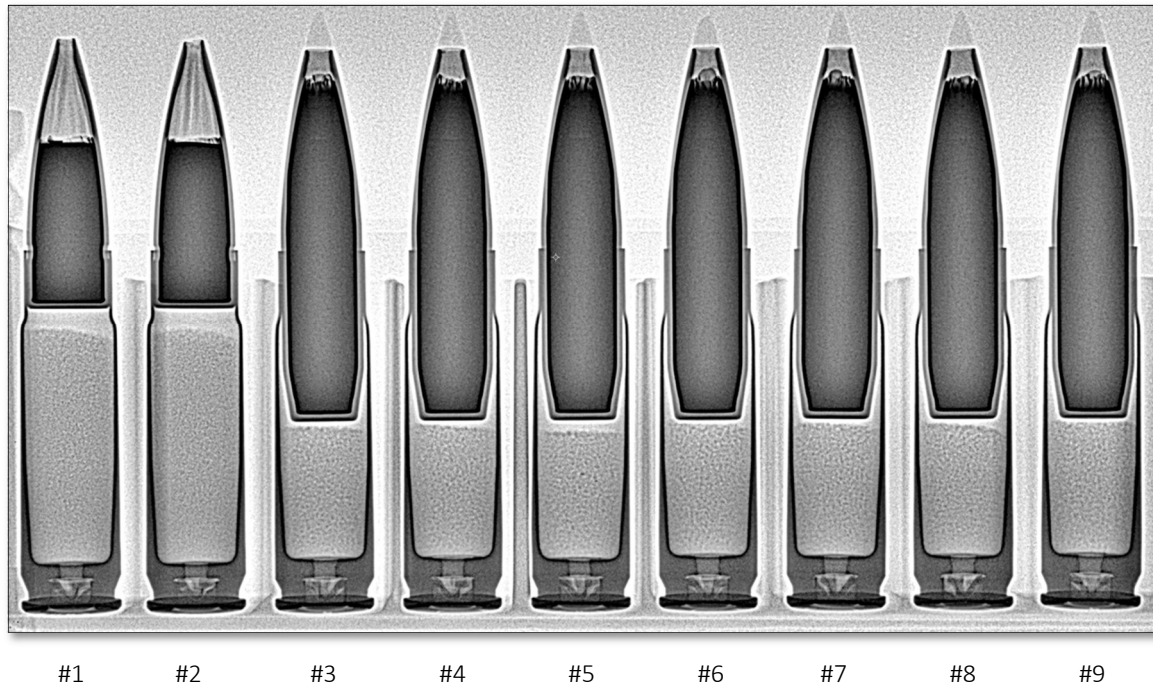
Figure 8.1.5: X-ray Comparison of the Nine Unfired Cartridges

The 2D x-rays of the ammunition identified the two Barnes cartridges had smaller bullets than cartridges three through nine. See Figure 8.1.5. The use of the larger bullets indicates cartridges three through nine are loaded to be subsonic ammunition (the bullet travels less than the speed of sound). Of the subsonic ammunition, cartridge five (the Lake City shell) appeared to have the least amount of propellant. This suggests that the Lake City cartridge may have been loaded at a different time than the Winchester cartridges or an inconsistent auto propellant thrower/loader was used to load all of the subsonic cartridges. The x-rays also show the two Barnes cartridges contained a different propellant than the other

cartridges. The propellant in cartridges 3, through 9 appear to be the same or very similar in density.

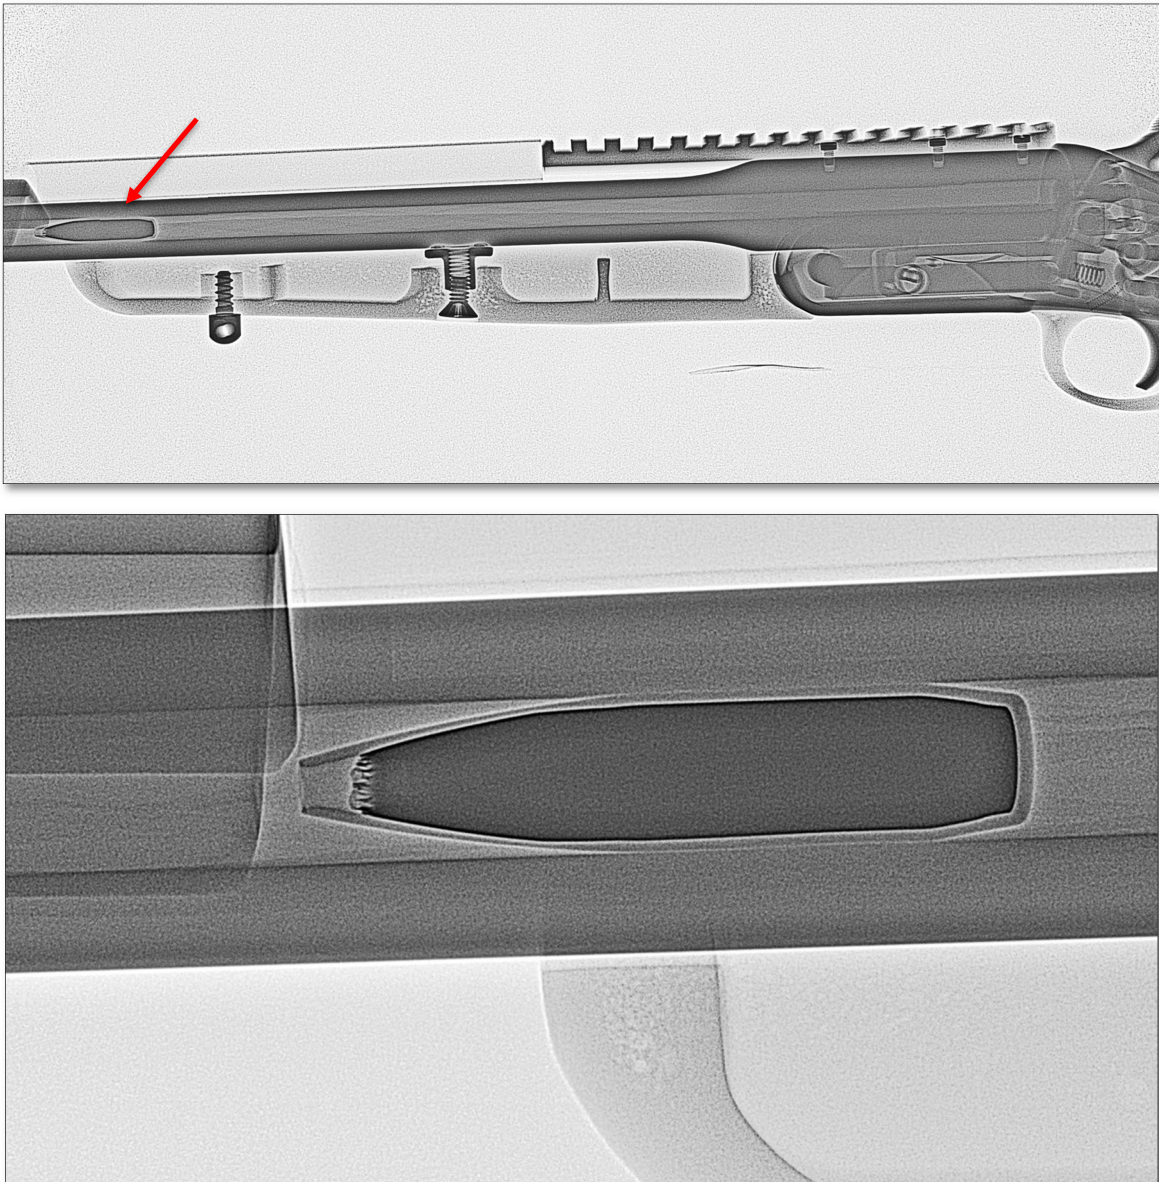
Figure 8.1.7: X-Ray of the Incident Bullet Lodged in the Barrel of the Subject Rifle

X-rays of the incident bullet showed it was lodged approximately 10.5 inches down the bore from the breech face. See Figure 8.1.7. The x-rays also showed the incident bullet was consistent in size with the heavy bullets observed in the unfired subsonic loaded cartridges (cartridges 3-9). Therefore, it is probable the incident shell was constructed from a repurposed Winchester or Lake City shell and contained the same improper geometry observed in those shells. As state earlier, an improperly formed shell can prevent a rifle from locking up properly or locking at all when closed.

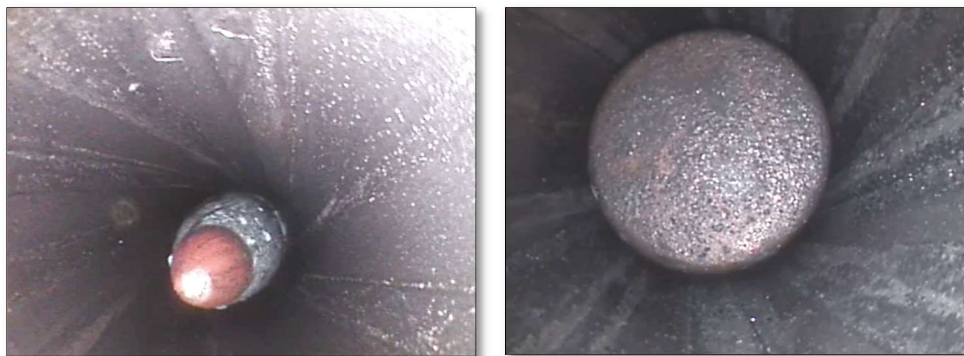
Figure 8.1.8: Video Borescope Images of the Tip and Heel of the Incident Bullet

A video borescope was used to memorialize the condition of the incident bullet before it was removed from the barrel. The borescope images showed the bullet had an unidentified white/silver colored substance covering the exposed copper jacket portions of the bullet. The plastic ballistic tip was free of the unknown substance, suggesting the substance was an oxide or carbon buildup. See Figure 8.1.8. The GoPro video Gopr5587 showed Mr. Batts adding CLP to the chamber and bore before the second shot was fired. The observed buildup on the incident bullet's jacket may have been influenced by the presence of residual CLP when the third shot was fired.

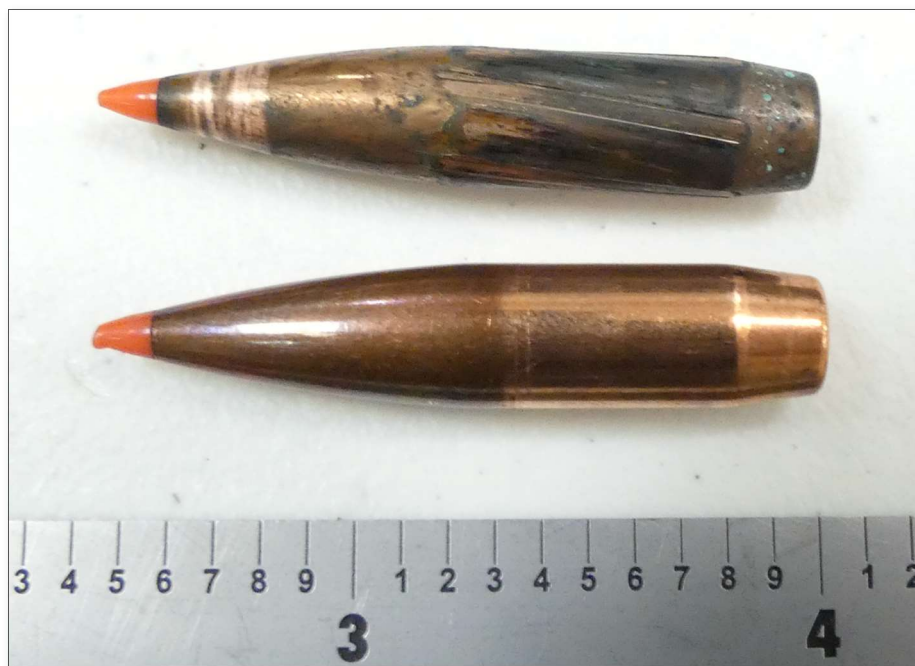
Figure 8.1.9: Comparison of the Incident Bullet (Top) and the Cartridge #3 Bullet (Bottom)

A cleaning rod was used to tap the bullet out of the barrel from the muzzle end to the chamber. The cleaning rod had a pocket on its end that cupped the nose of the bullet. By driving the bullet out of the barrel by applying pressure to the cone of the bullet and not the nose, the bullet was removed without altering its length or damaging the ballistic tip. Once extracted, it was confirmed the subject bullets dimensions matched a Hornady 30cal, 208 grain, ELD Match and A-Max (Litz) bullet. See Figure 8.1.9. The difference between the Hornady 30cal, 208 grain, ELD Match bullet and an A-Max bullet is the polymer ballistic tip. Dimensionally the two bullets are equivalent.

Comparing the incident bullet to the cartridge #3 bullet showed the two bullets were of the same make. See Figure 8.1.9. Mr. Powell indicated in his initial report that the incident bullet was 1.375 inches in length. Mr. Powell's measurement technique was incorrect by approximately 0.168 inches.

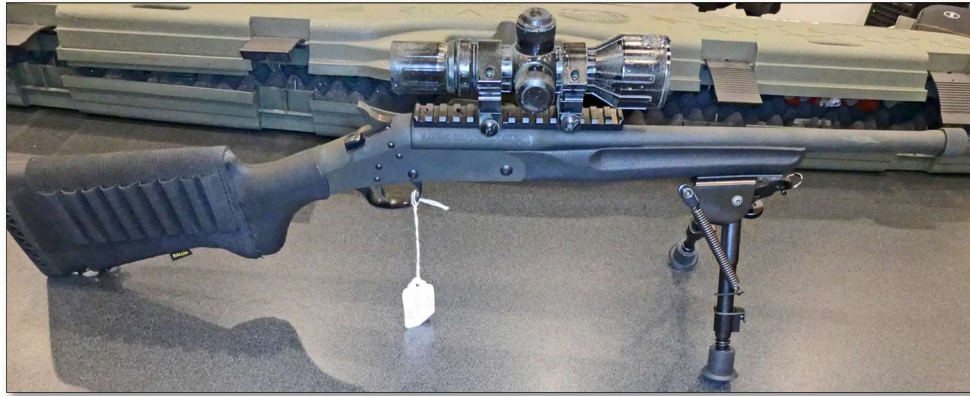
Figure 8.2.1: Incident H&R Handi-Rifle Chambered in 300 AAC Blackout

Externally the rifle appeared to be in a well-kept condition, no overt signs of abuse or alteration were observed. See Figure 8.2.1. The rifle was photographed externally, but Mr. Powell asked that the rifle's action not be opened until after the CT was completed. I complied with Mr. Powell's request and the rifle was verified to be unloaded via x-ray and then was CT scanned without being opened or functioned in any way.

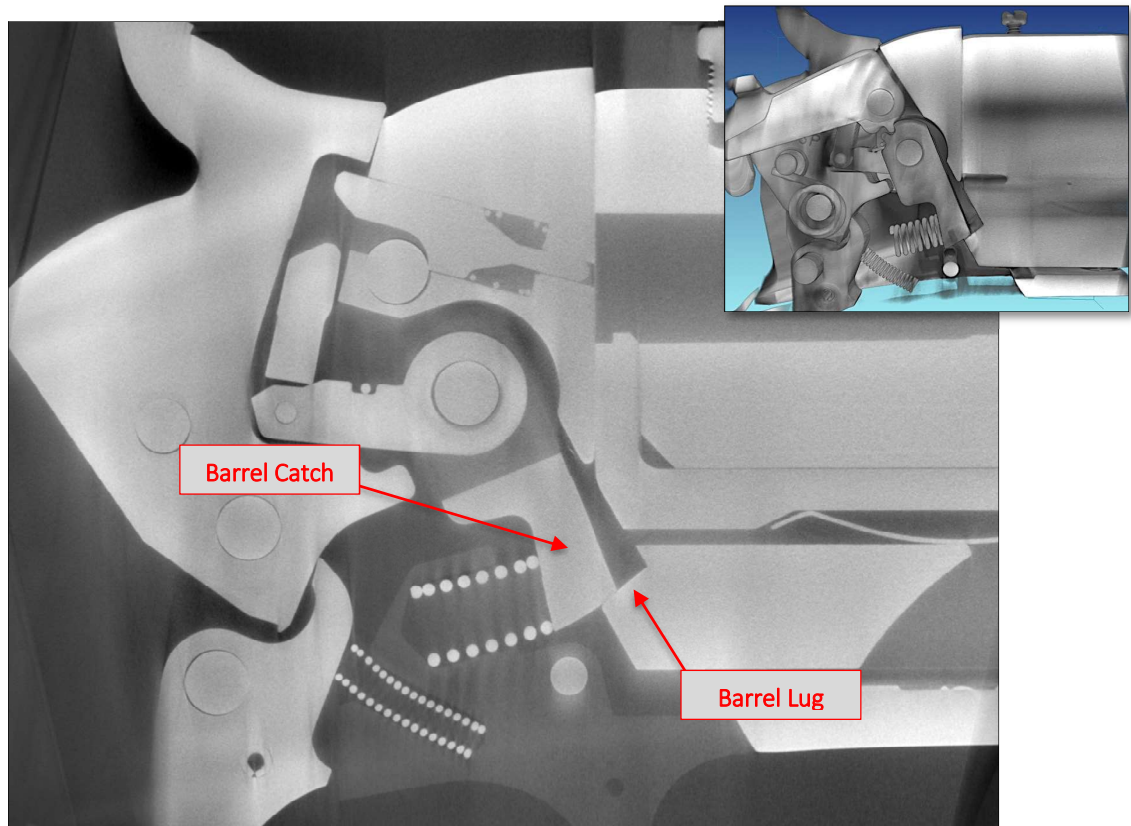
Figure 8.2.2: CT Slice Through the Center of the Subject Rifle

The CT showed the rifle contained no broken or altered components. The area of focus was the barrel catch and the barrel lug. When the action of the rifle is closed, the barrel

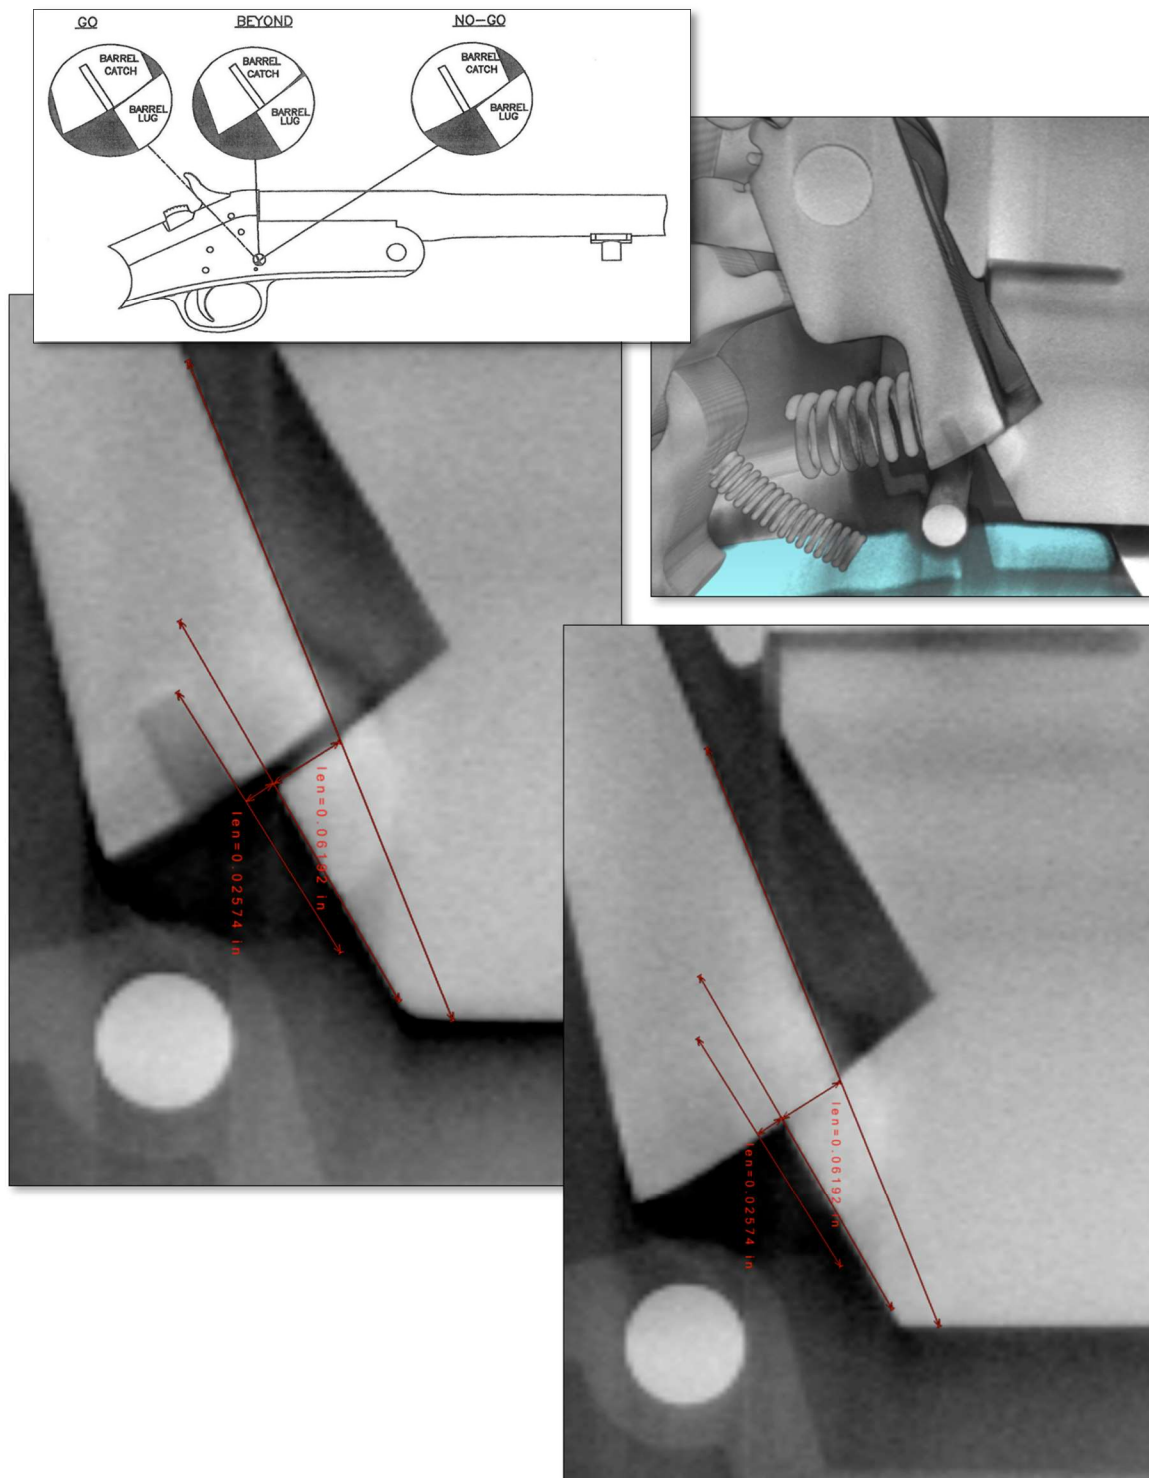
Figure 8.2.3: CT Measurements of the Engagement Between the Barrel Catch and the Barrel Lug

catch swings over the barrel lug and locks the barrel into the receiver. See Figure 8.2.2. Using the CT software, the engagement between the barrel catch and the barrel lug was measured to be 0.062 inches. Per the factory specifications the rifle's lockup was 29.5% under the minimum specification of 0.088 inches. See Figure 8.2.3.
